Manhole Inspection Summary

Manhole # S55C2_004MH

Location Address: **3701 4th Ave.**

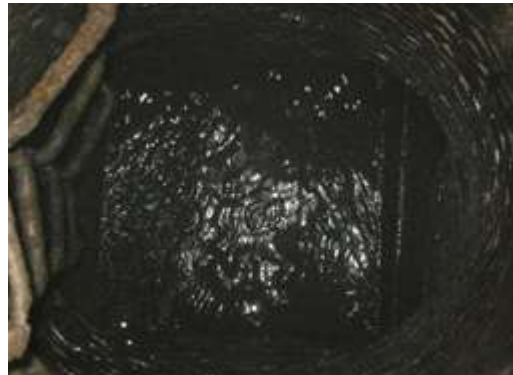
Top View

**Manhole is too deep for accurate measurement with pipe mic.
Top picture is best possible shot.**

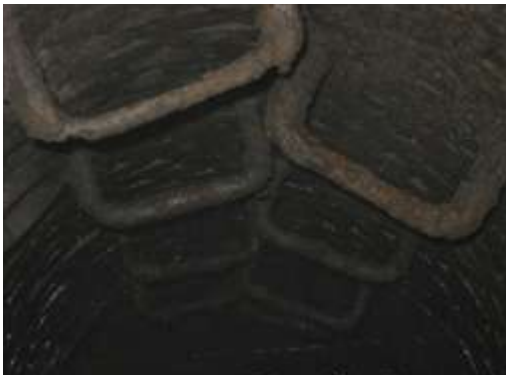
Steps Count: **8** Missing: **0** ☒ **Corroded**

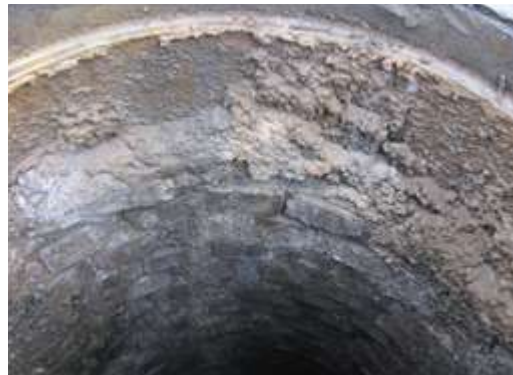
Defect 2

Infiltration: ☐ None ☒ **Joint** ☐ Cracks ☐ Mortar ☐ Roots ☐ Wall

Infiltration through the Frame-Chimney Joint

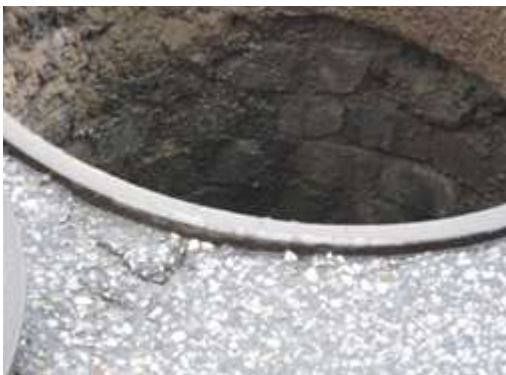
Defect 1

Cover Shape: **Circular** Diameter: **24** (in.) Length: (in.) Dist A/B Grade: **0.5** (in.)

Frame above the grade.
